**UNITED STATES DEPARTMENT OF ENERGY
NAVAL PETROLEUM RESERVES IN CALIFORNIA**

***GEOLOGY
OF THE
TUPMAN AREA***

***ANALYSIS OF SURFACE FRACTURES
ASSOCIATED WITH DISPOSED WATER
BREAKOUT OF WELL 58WD-7G, 10/23/93***

By
Mark Milliken
DOE Staff Geologist

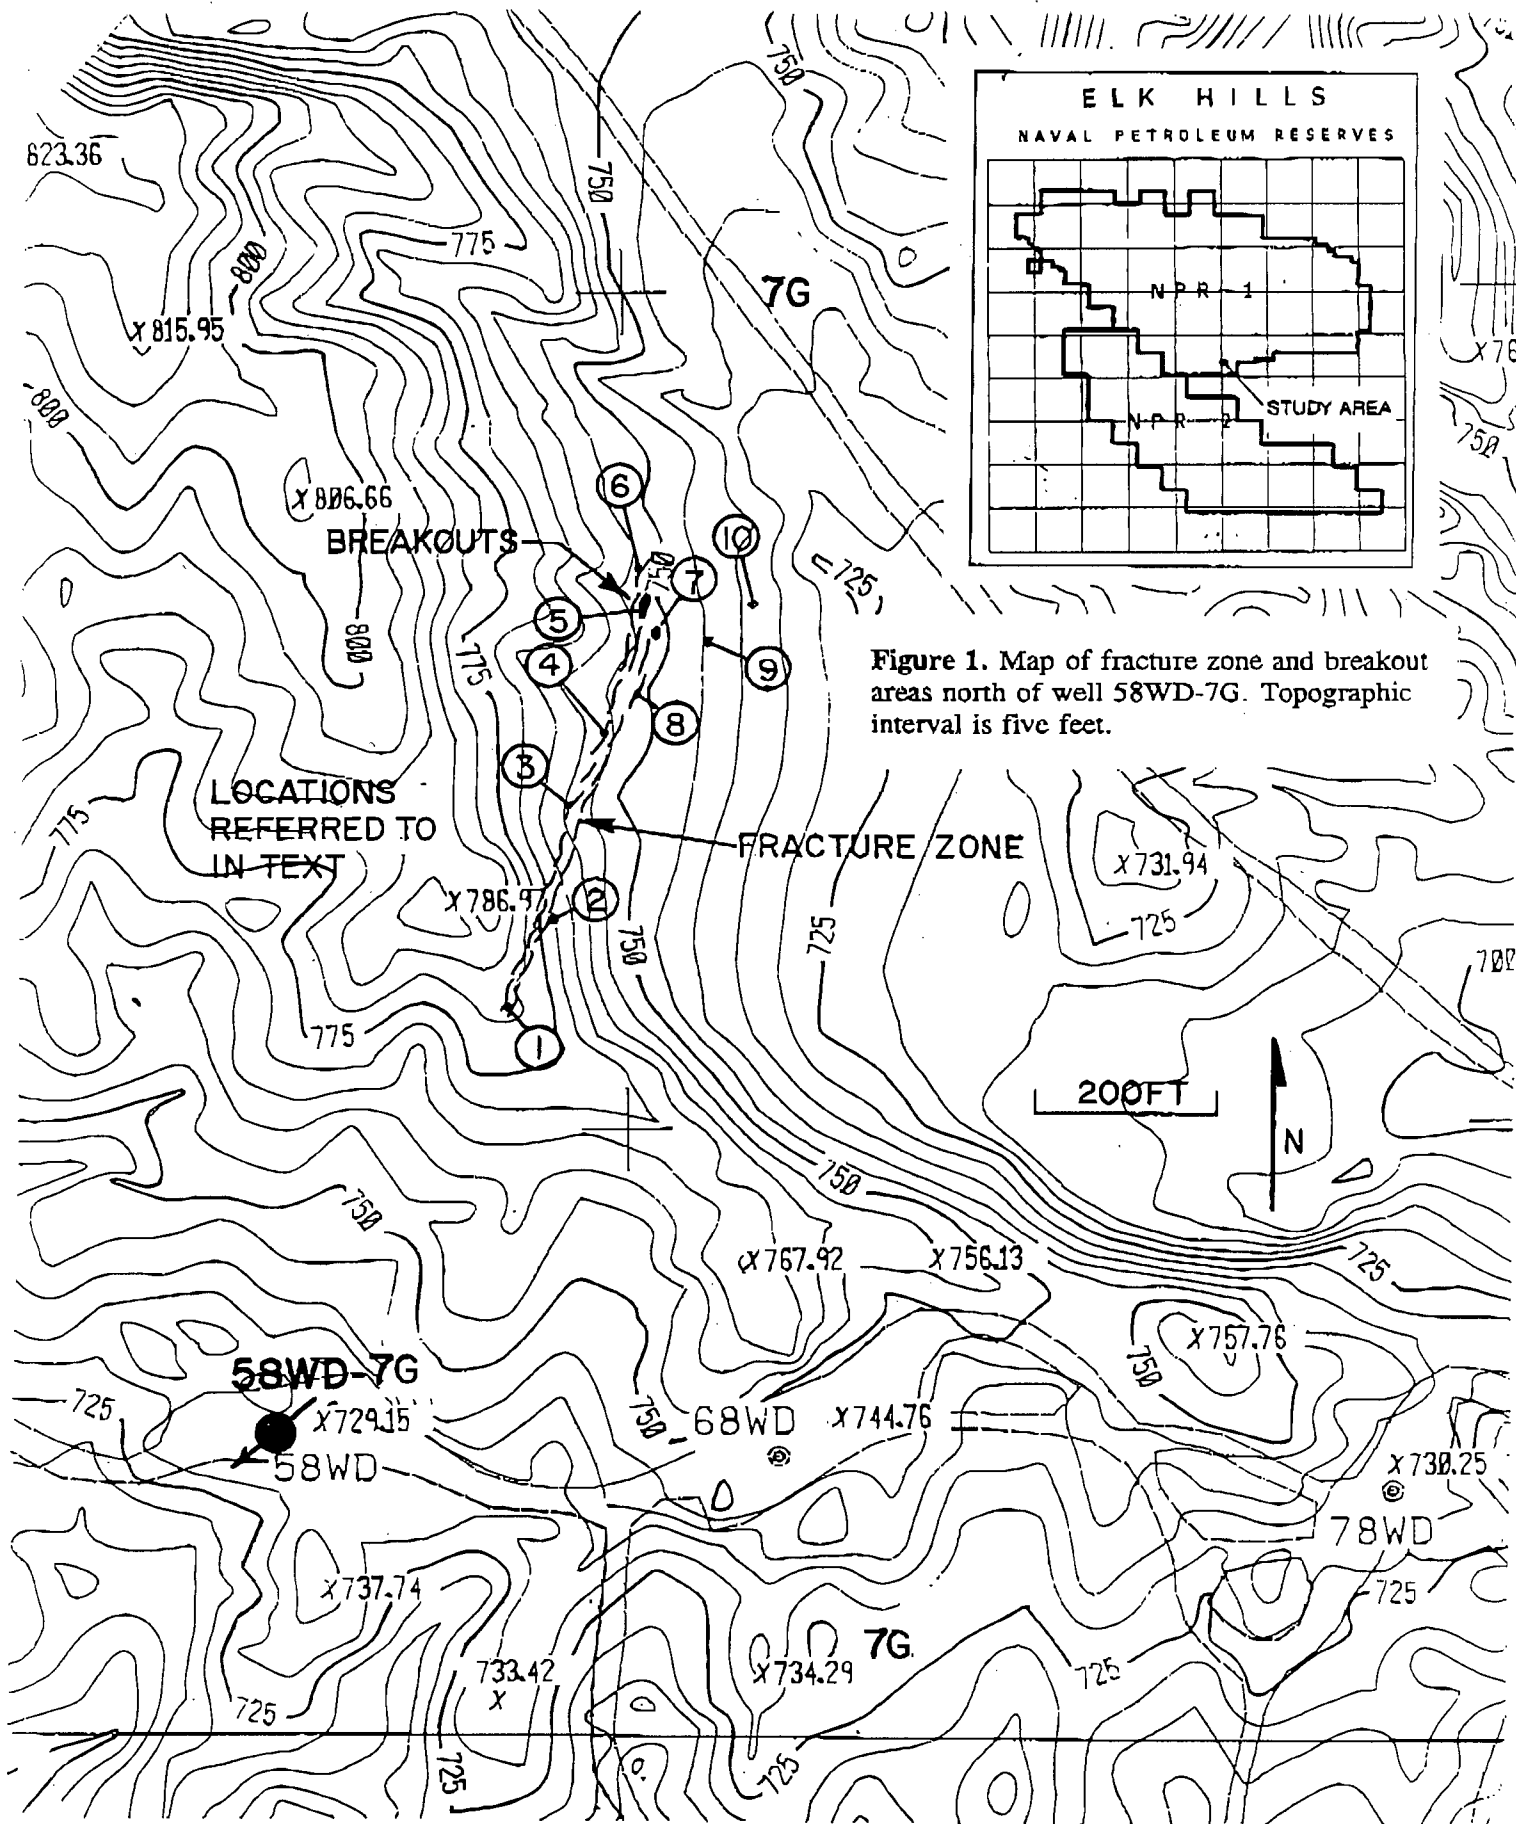
On October 25, a field party consisting of Tony Reid, Harvey Deutsch, and myself visited the location. Several fresh fractures were noted around the breakout vicinity. The fractures continue to the southwest, aligned along a northeast-southwest trending zone. The fractures stop on a ridge about 500 ft southeast of the breakouts. On the ridge near hill 786.97, the alignment of the fracture zone with well 58WD-7G became obvious. On October 26, I made a follow-up visit to photograph the fractures and take detailed notes. The fractures showed evidence of different ages, and they were oriented oblique to the general trend of the fracture zone. Rough locations of the fracture zone and breakouts were triangulated using a Brunton compass. The approximate location of the largest breakout is 1060 ft from well 58WD-7G on a bearing of N. 18° E. (figure 1). The breakout coordinates are roughly 1370' N., 1883' W. of the SE corner, section 7G.

Fracture orientation. The fractures occur in a left-stepping *en-echelon* pattern along a 10 ft wide zone. The zone is about 500 ft long and begins 560 ft northeast of well 58WD-7G (figure 1). The fracture zone strikes N. 18° E., and the fractures are oriented $\pm 20^\circ$ obliquely to the east. Fracture trends range from N. 20° E. to N. 55° E., with the strongest trend being between N. 30°-50° E. (figure 2). Some fractures are oriented to the NW and may not be associated with the subject fracture zone.

Cause of fracturing. The fracturing is clearly related to the release of disposed water at the surface. The surface disturbance may be an extension of a pre-existing fracture at depth reactivated by increased injection pressure in Tulare rocks. No lineament analysis was done within the area surrounding the fracture zone. Airphotos do show weakly developed NE trends in drainages and photo-linears, although there is no specific indication of surface jointing coincident with subject fracture zone. The strongly developed left-stepping *en-echelon* fracture fabric suggests right-lateral wrenching may be involved.

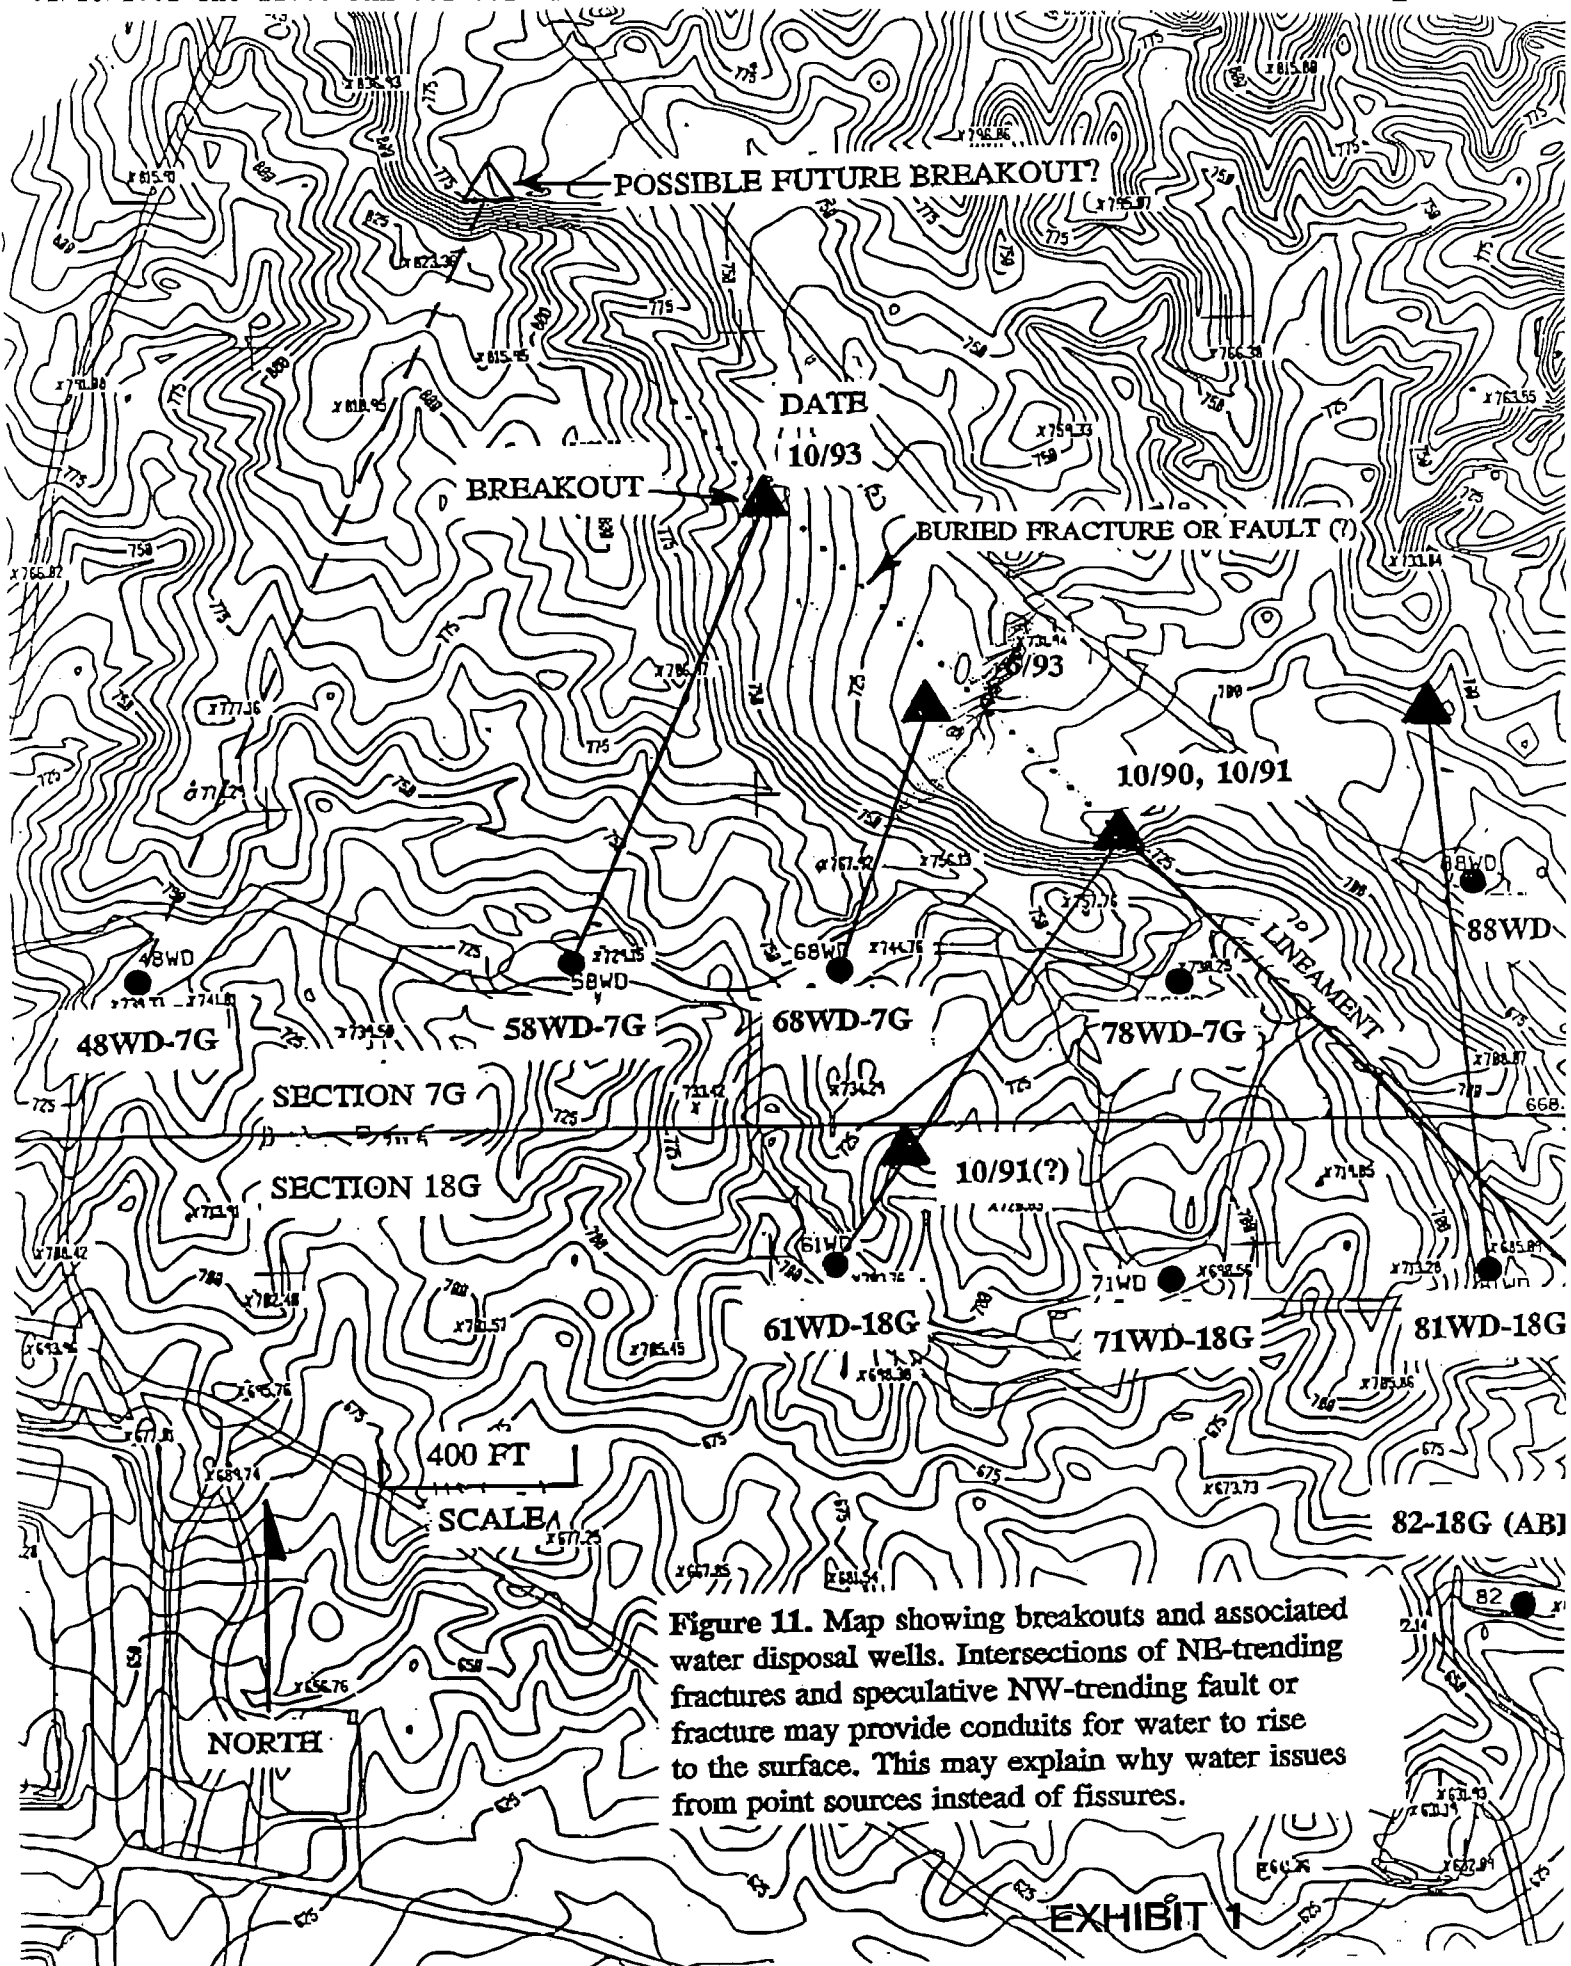
Figure 11. Map showing breakouts and associated water disposal wells. Intersections of NE-trending fractures and speculative NW-trending fault or fracture may provide conduits for water to rise to the surface. This may explain why water issues from point sources instead of fissures.

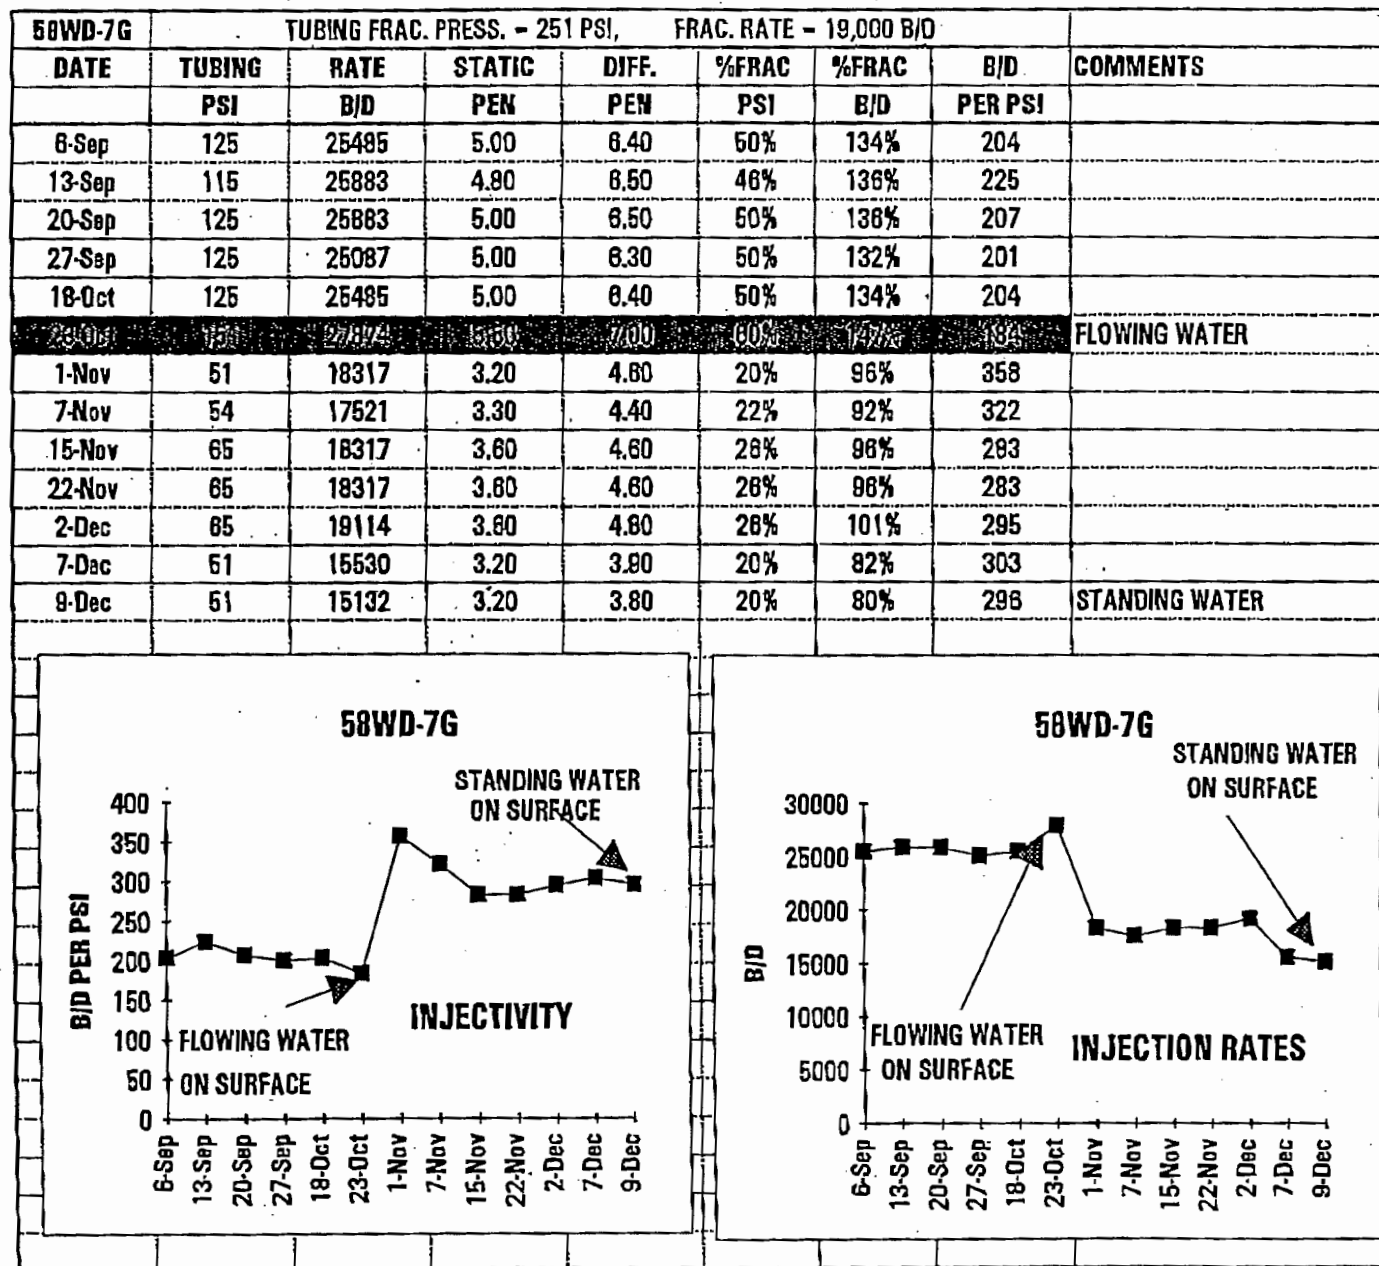
EXHIBIT 4

Exhibit 4 shows flow rates and tubing pressure data for well 58WD-7G for the periods before and after Oct. 23. Associated charts show injectivity (B/D per psi) and flow rates for the period. Injectivity increased markedly after the Oct. 23 breakout, suggesting the fractures may have allowed injected water access to stratigraphically higher gravels. Standing water in the breakout depression occurs at an injection rate of 15,000 B/D. When the rate is reduced, the standing water disappears.
